Marlow 66 Explorer CB

"Sweetie"

**GENERAL CONDITION, INSURANCE RISK
AND VALUE SURVEY**

March 14, 2024

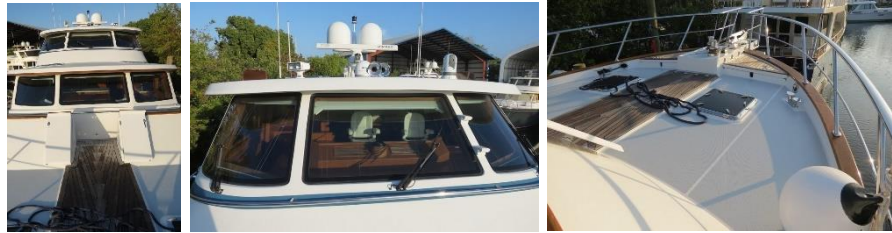
Decks & Superstructure:

Molded fiberglass with sandwich core construction and paint finish. [Vinylester resin, closed cell foam and vacuum bagged] Teak decks with teak runner at bow.
Condition: Sound to the hammer where sounded.

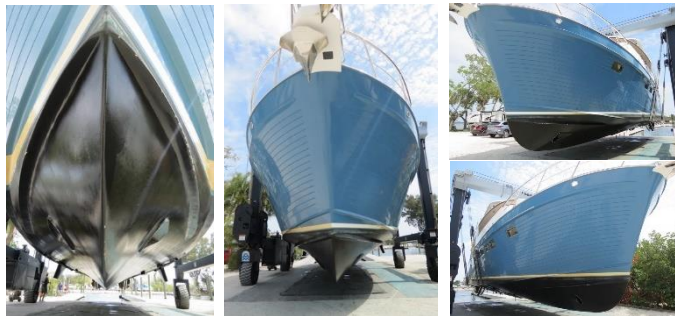
Hull Bottom:

Molded fiberglass with sandwich core construction and antifouling bottom paint applied. [Vinylester resin, Kevlar, closed cell foam and vacuum bagged]
Modified Vee with propeller pockets over twin strut keels.
Condition: Clean and sound to the hammer where sounded.

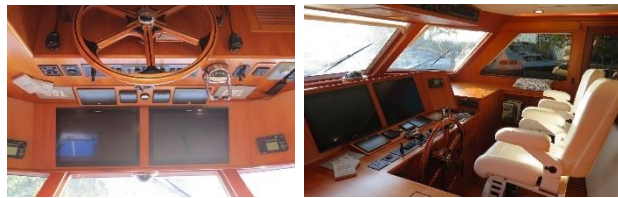
Steering Gear: Hydraulic.
Top up master cylinder.
(Proven functional)

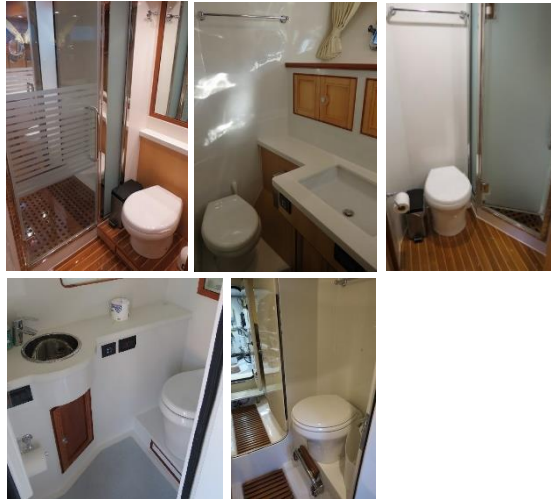
Marine Toilets: Six (6) total toilets. (Five (5) Vacu Flush with 24 Volt DC power)
((See Recommendations))

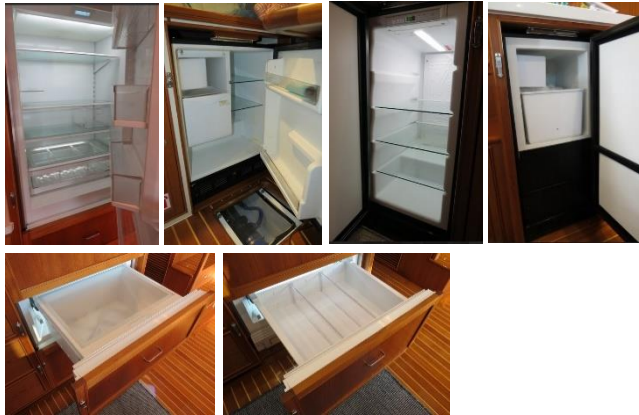
Refrigeration: Sub-Zero large open door refrigerator.
U-Line 2115 refrigerator / ice maker at bridge.
Two (2) Sub-Zero drawer freezer at aft galley.
Two (2) Sub-Zero drawer freezer at forward galley.
(All Proven functional)
